STRUCTURAL SURVEY REPORT

VICTORIA HALLS,

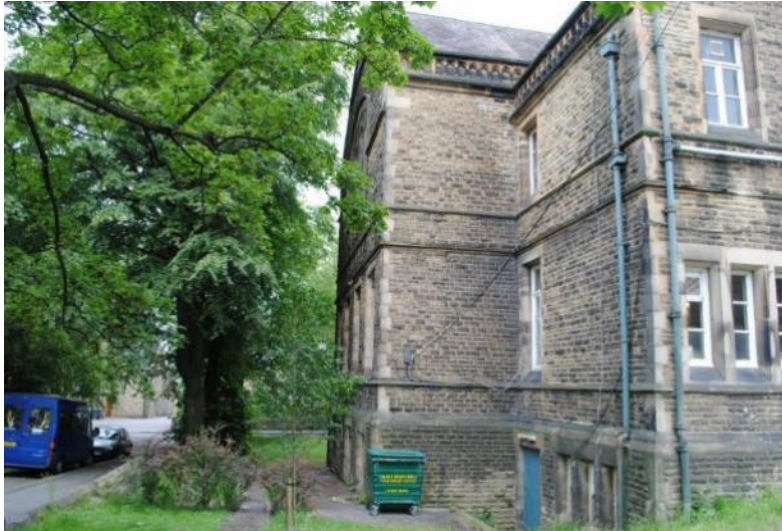
FIGURE 4 –SOUTH ELEVATION ILLUSTRATING THE PROXIMITY OF TRESS IN THE SOUTH-WEST CORNER

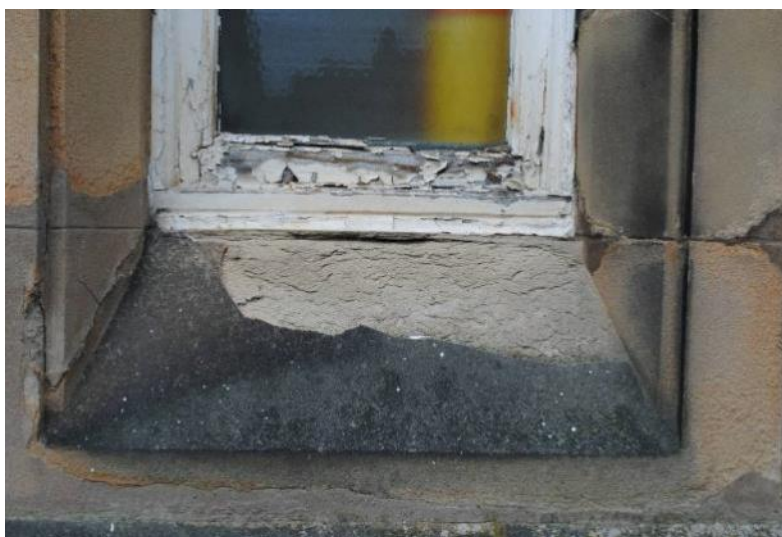
FIGURE 5 –TYPICAL EXAMPLE OF THE CONDITION OF WINDOW FRAMES

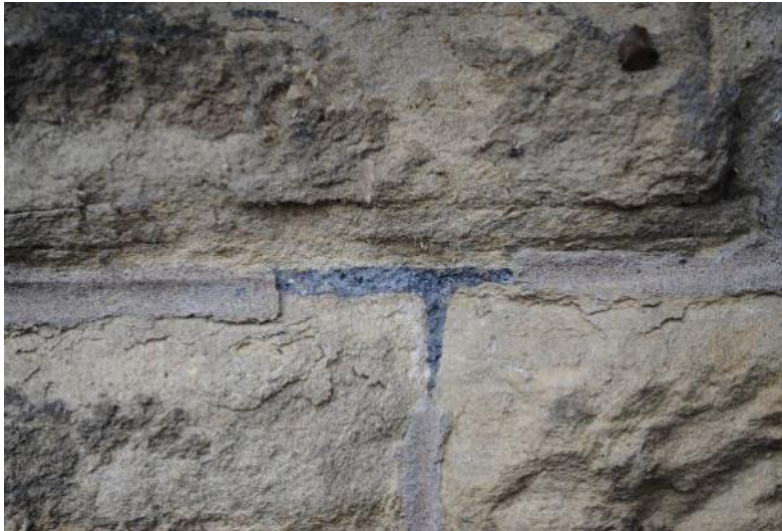
FIGURE 6 – TYPICAL EXAMPLE OF THE POINTING TO THE FACING STONework. EARLIER LIME/ASH MORTAR IS EVIDENT BEHIND THE MOST RECENT REPOINTING.

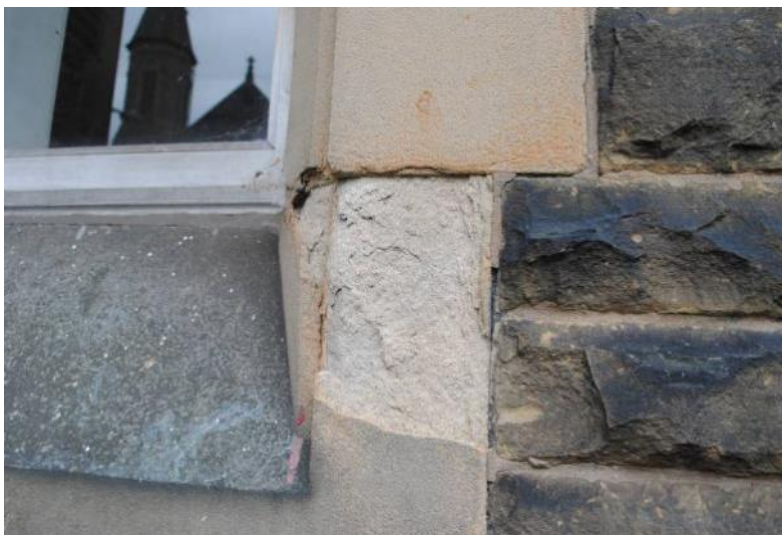
FIGURE 7 – TYPICAL EXAMPLE OF STONework WITH A SPALLED FACE

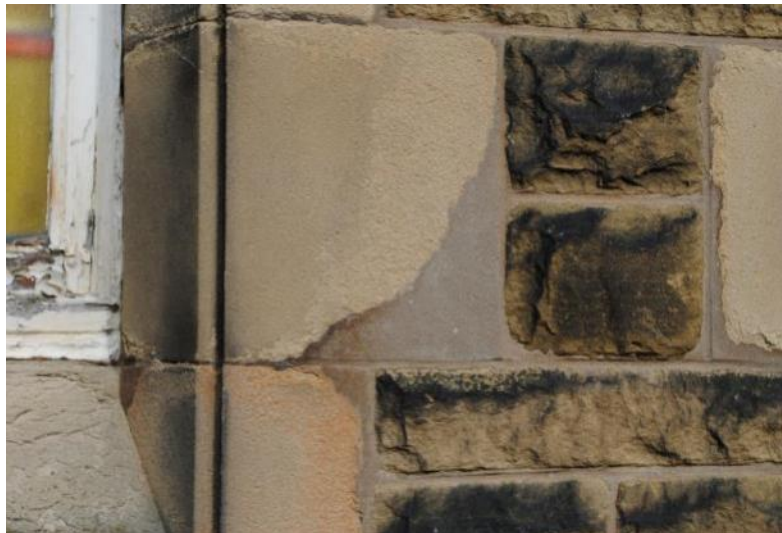
FIGURE 8 - EVIDENCE OF PREVIOUS REPAIRS OF THE STONE BLOCKS.

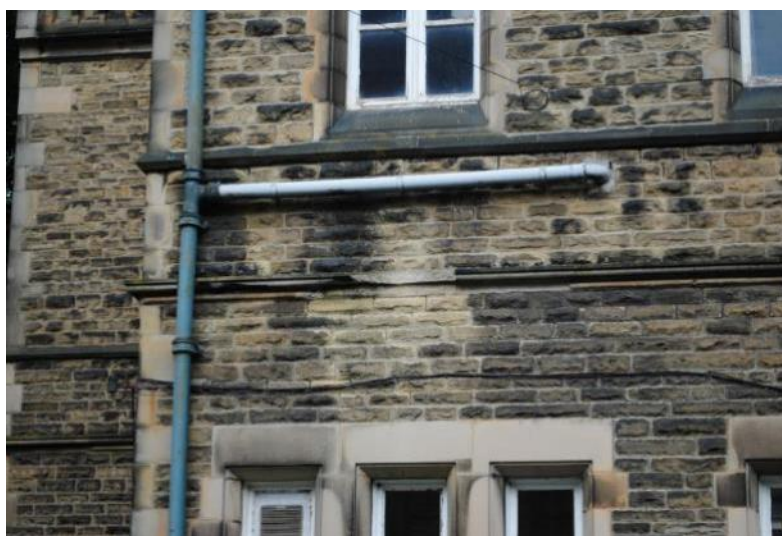
FIGURE 9 – EXAMPLE OF BROKEN BAND COURSE

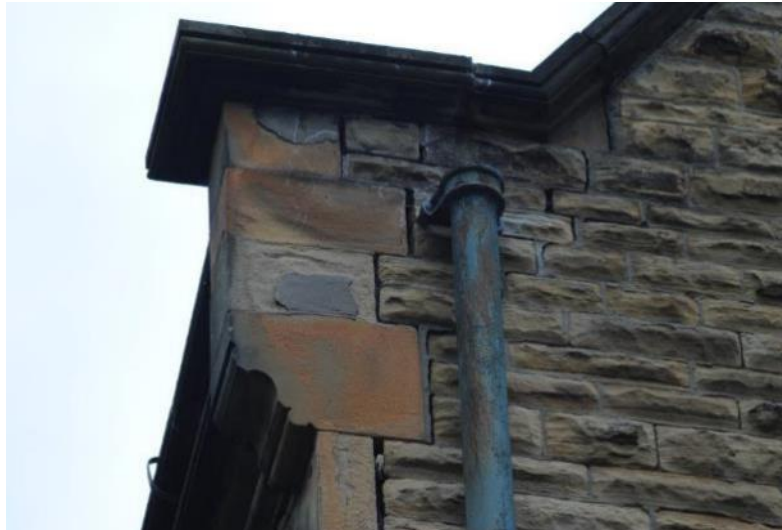
FIGURE 10 – EXAMPLE OF LOOSE POINTING, OPEN JOINTS AND MOVEMENT IN STONework AT PARAPET LEVEL. THIS DEFECT OCCURS IN MULTIPLE LOCATIONS.

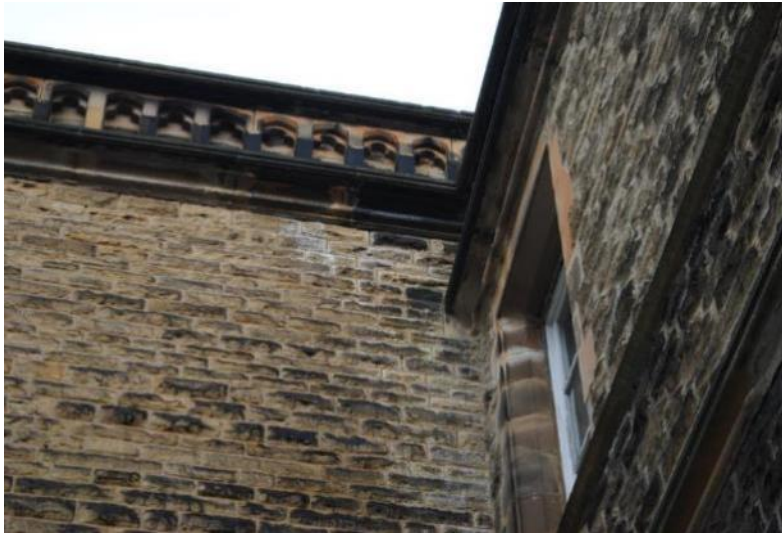
FIGURE 11 – EXAMPLE OF SALT STAINING IN THE STONework AT PARAPET LEVEL

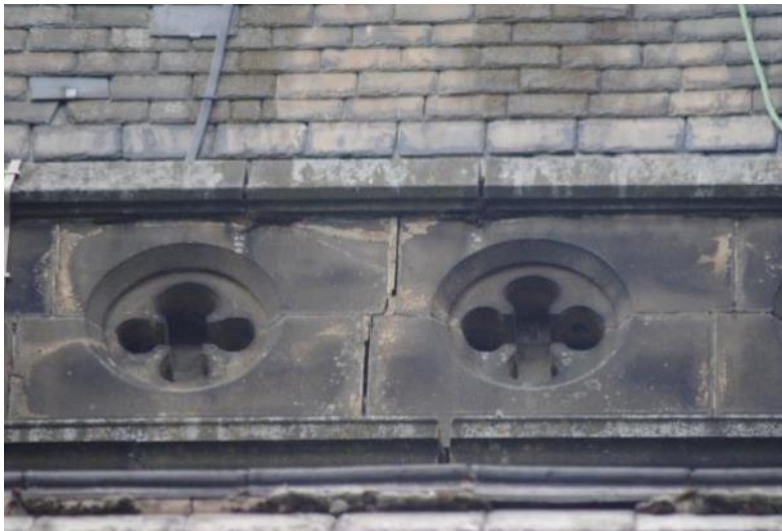
FIGURE 12 – EXAMPLE OF OPEN JOINTS AND LOOSE MORTAR AT THE PARAPET LEVEL OF THE TOWER

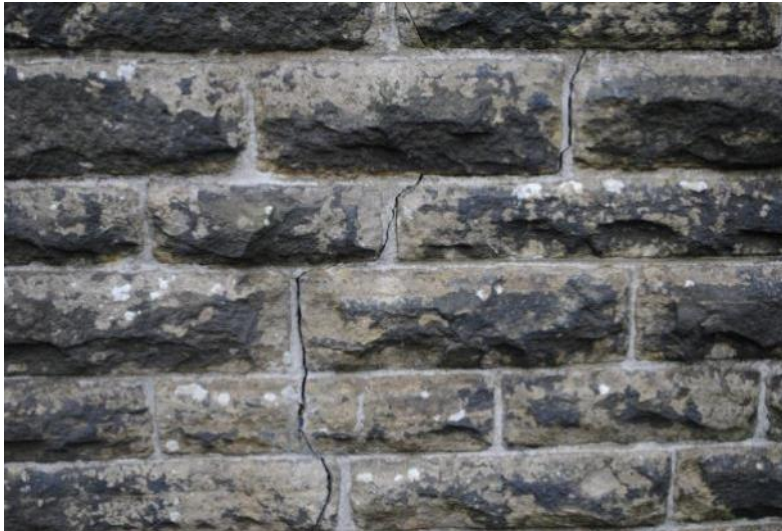
FIGURE 13 – EXAMPLE OF MINOR SETTLEMENT CRACKING

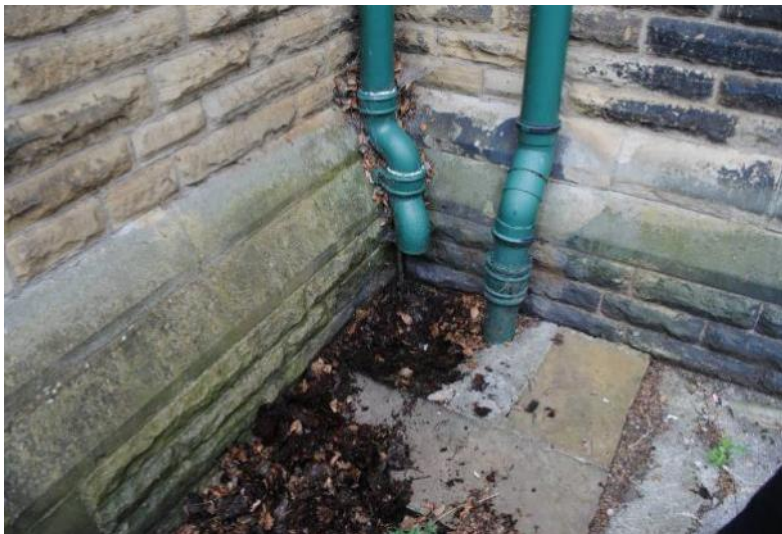
FIGURE 14 – EXAMPLE OF BLOCKED GULLY

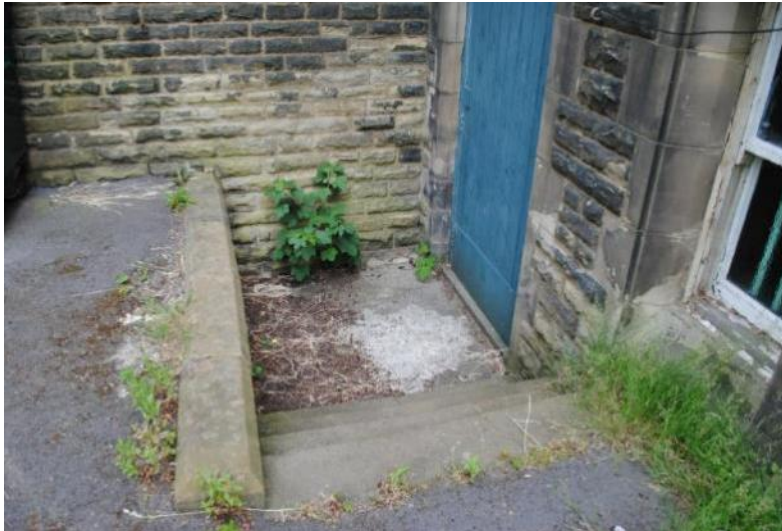
FIGURE 15 – EXAMPLE OF ACCESS TO THE LOWER GROUND FLOOR. THE SURFACE WATER GULLEY IS BLOCKED, VEGETATION IS GROWING IN THE GULLEY AND THE DOOR THRESHOLD HAS FAILED.

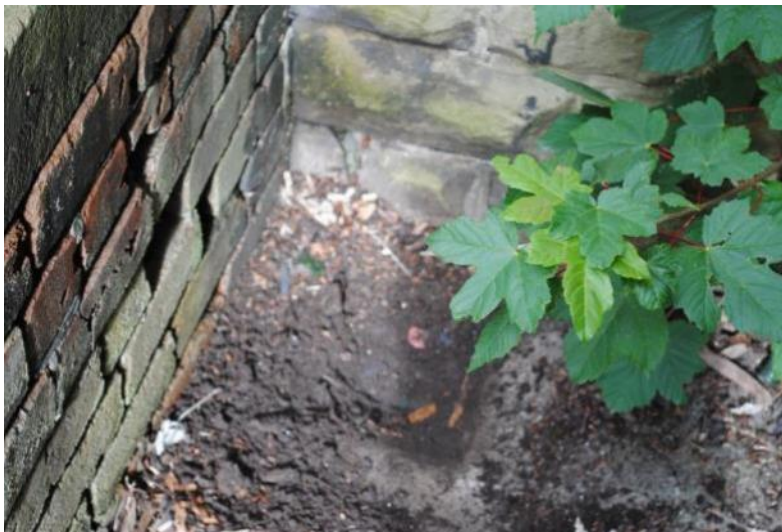
FIGURE 16 – EXAMPLE OF SILTED UP GULLEY

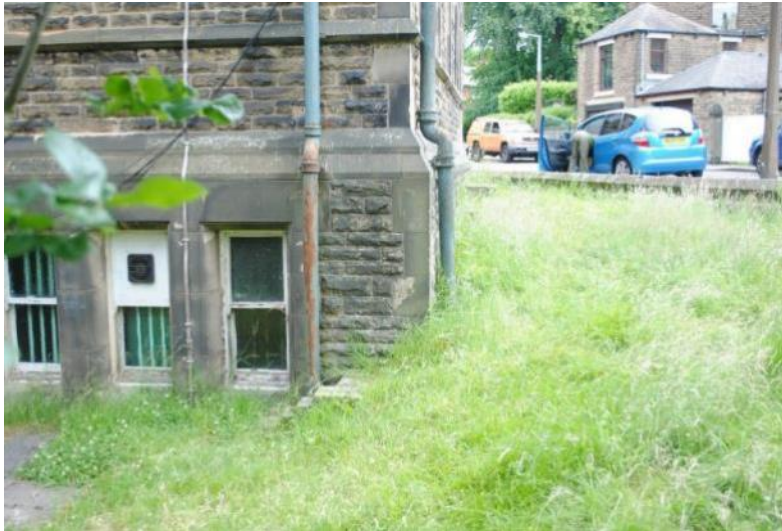
FIGURE 17 – PHOTOGRAPH ILLUSTRATING HOW THE EXTERNAL LOWER GROUND FLOOR WALL WHICH IS ACTING AS A RETAINING WALL. THE INTERNAL FACE OF THIS WALL IS DAMP.

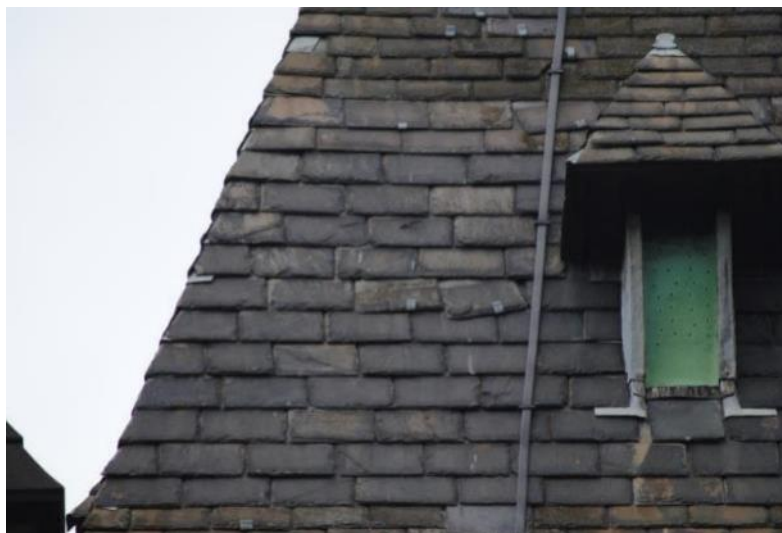
FIGURE 20 – EXAMPLE OF DAMAGED, LOOSE AND MISSING ROOF TILES.

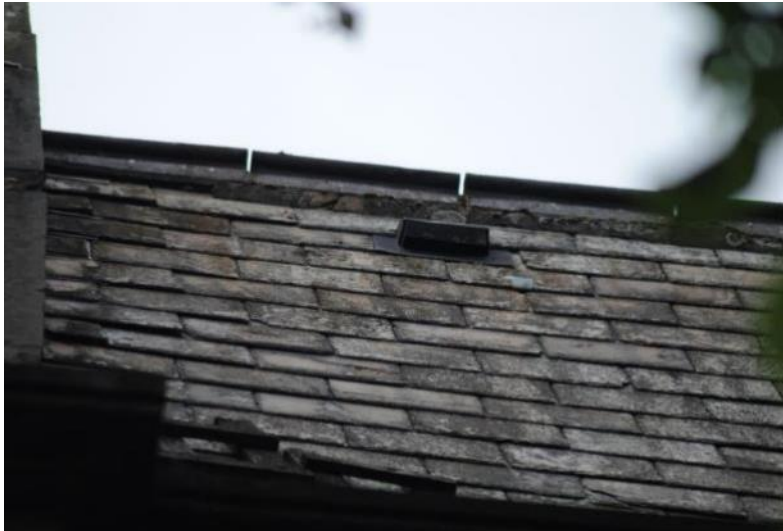
FIGURE 21 –EXAMPLE OF DAMAGED ROOF TILES, SOME HAVE SLIPPED OUT OF PLACE.

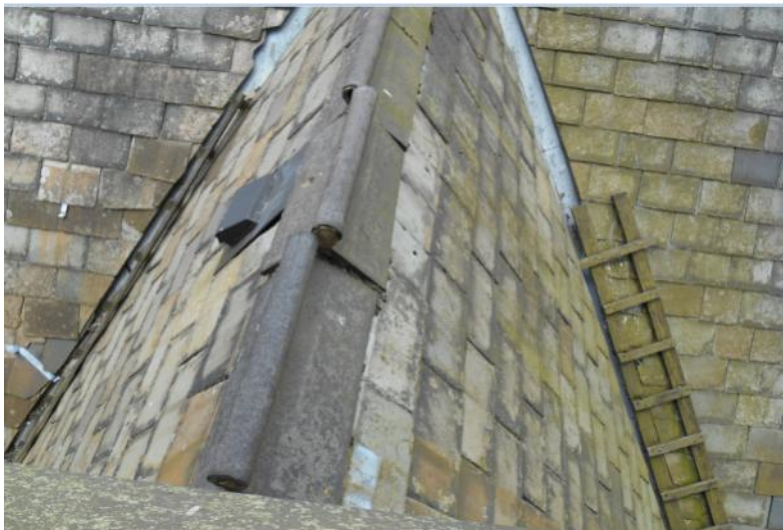
FIGURE 22 – EXAMPLE OF LOOSE RIDGE TILES

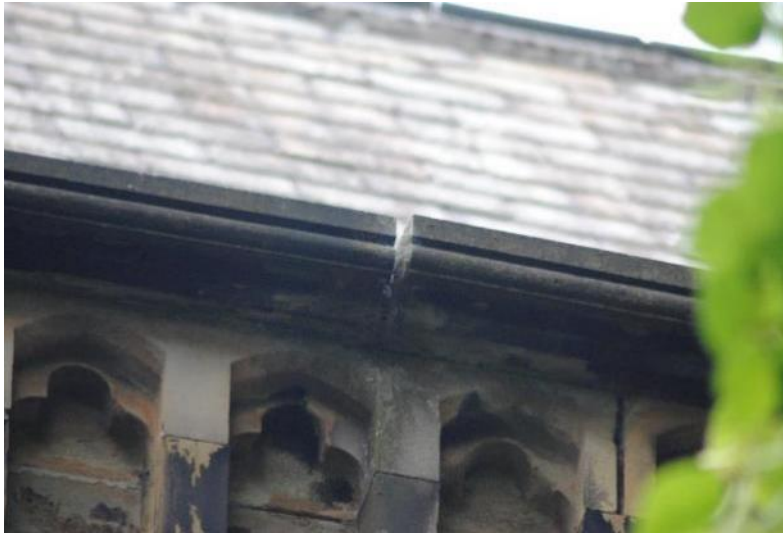
FIGURE 23 – EXAMPLE OF MOVEMENT AND CRACKING IN PARAPET WALL.

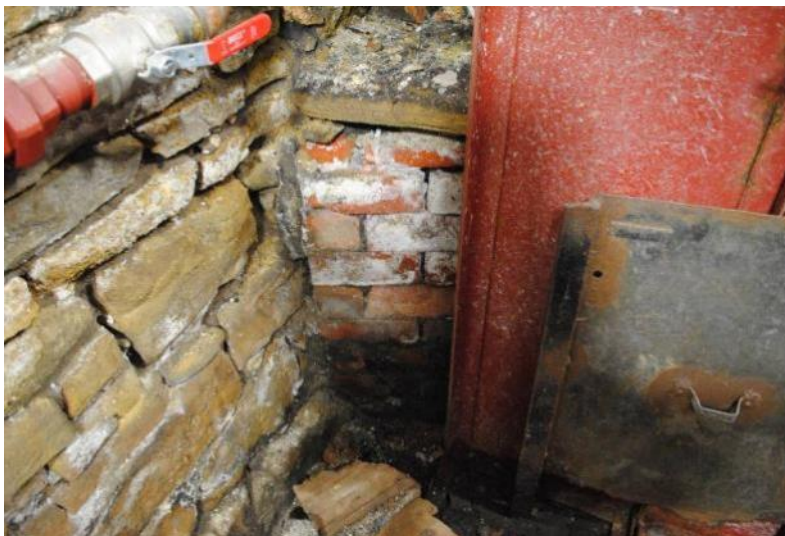
FIGURE 24 – EXAMPLE OF WATER INGRESS IN THE SHOWN BY DAMP BRICKWORK AND SALT STAINING

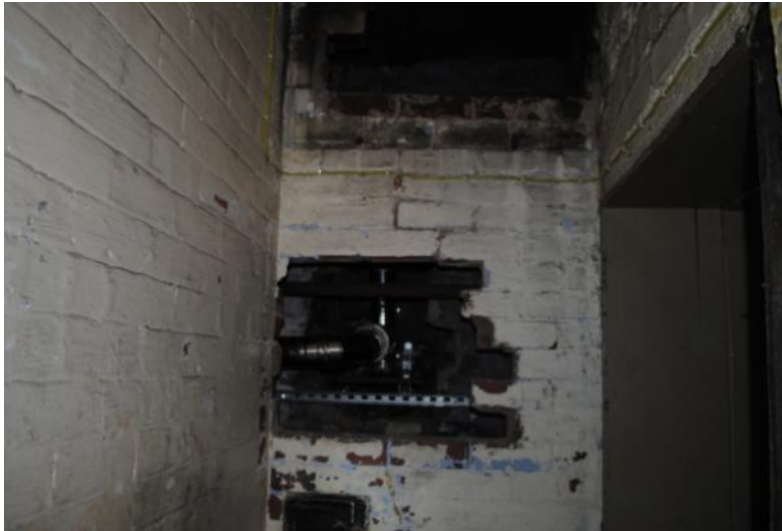
FIGURE 25 – MECHANICAL SYSTEMS BUILDER’S WORK HAVE BEEN POORLY COMPLETED. A LINTEL IS REQUIRED TO THIS PIPE OPENING.

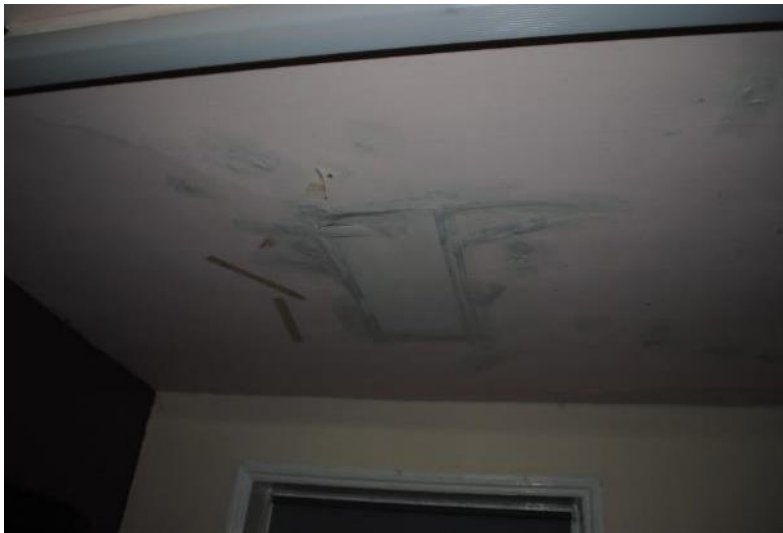
FIGURE 28 – EXAMPLE OF PREVIOUS POOR QUALITY REPAIRS TO CEILINGS

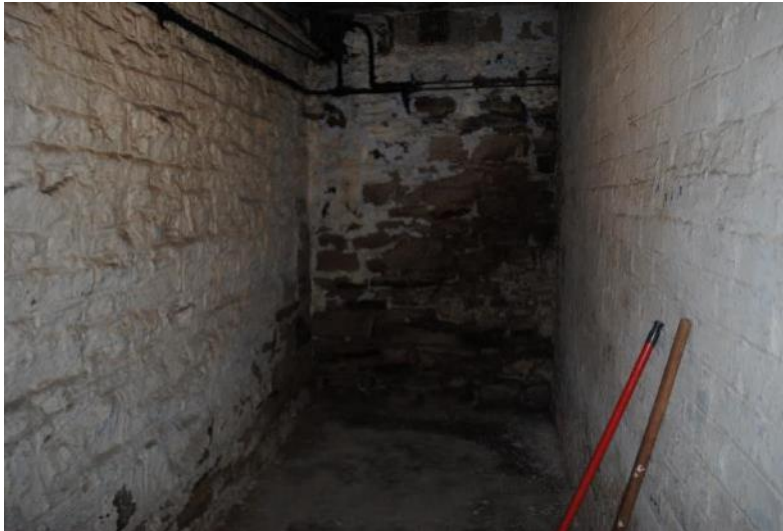
FIGURE 29 – EXAMPLE OF DAMP WALLS

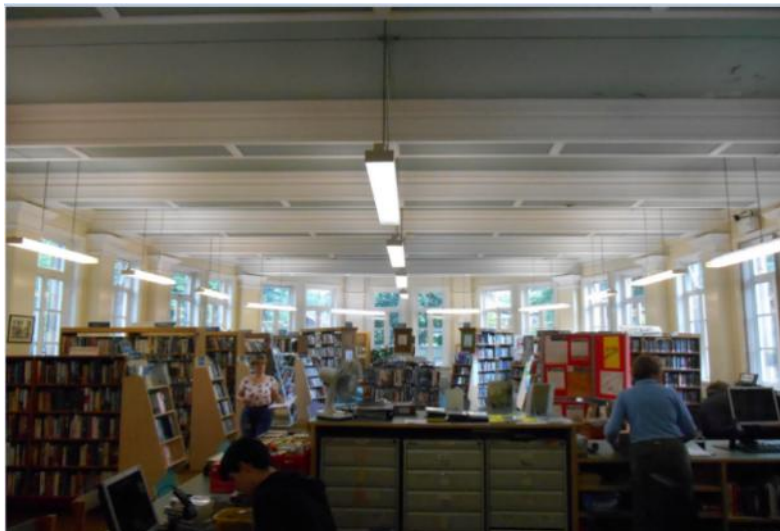
FIGURE 34 - GENERAL LAYOUT OF LIBRARY SPACE.

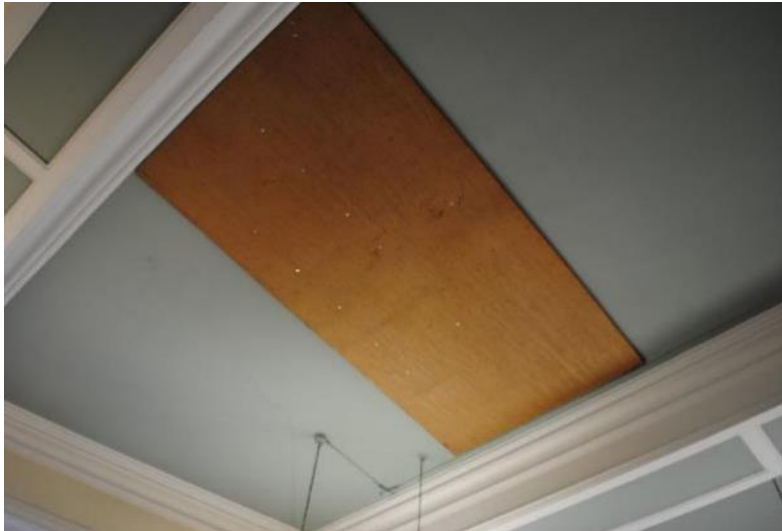
FIGURE 35 – EXAMPLE OF PLYWOOD BOARD ATTACHED TO CEILING TO PROVIDE A TEMPORARY REPAIR

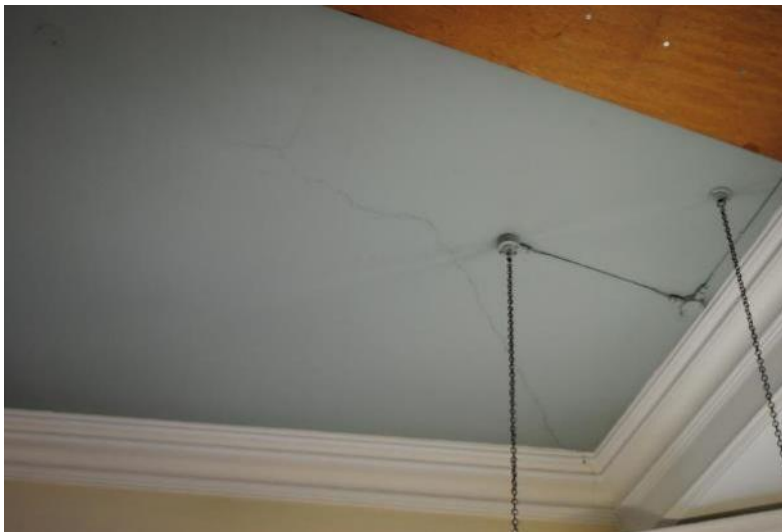
FIGURE 36 – EXAMPLE OF HAIRLINE CRACKING IN THE CEILING FINISHES

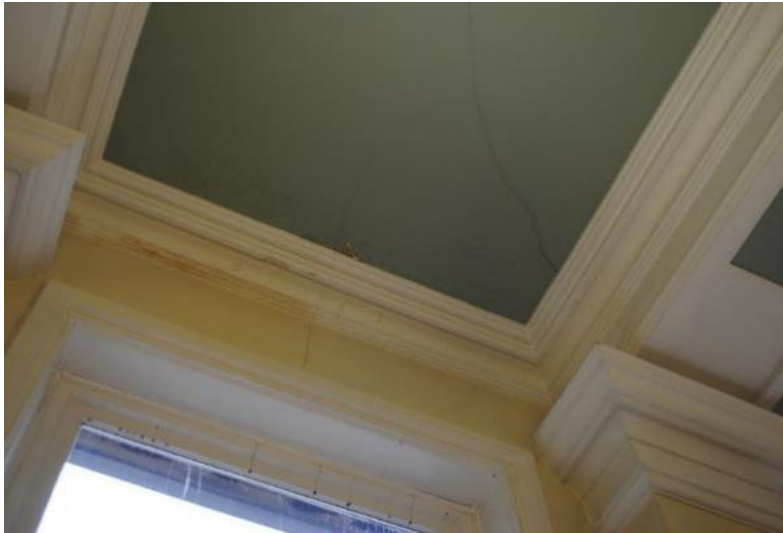
FIGURE 37 – EXAMPLE OF WATER INGRESS

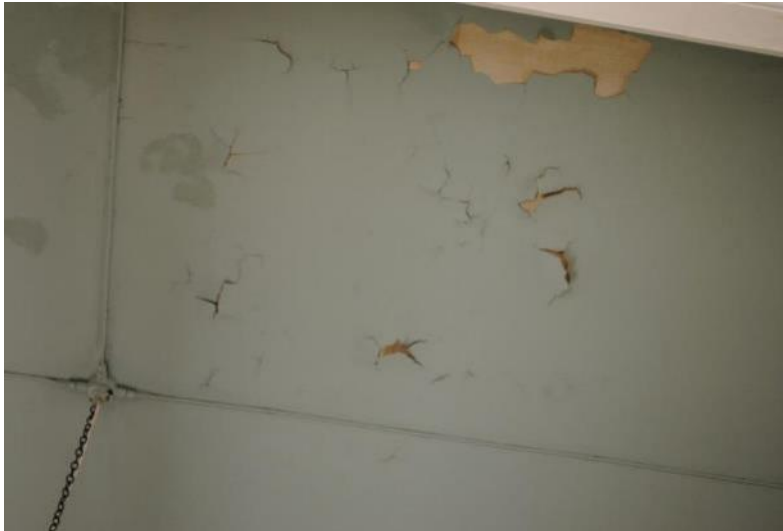
FIGURE 39 – EXAMPLE OF WATER DAMAGE TO CEILING.

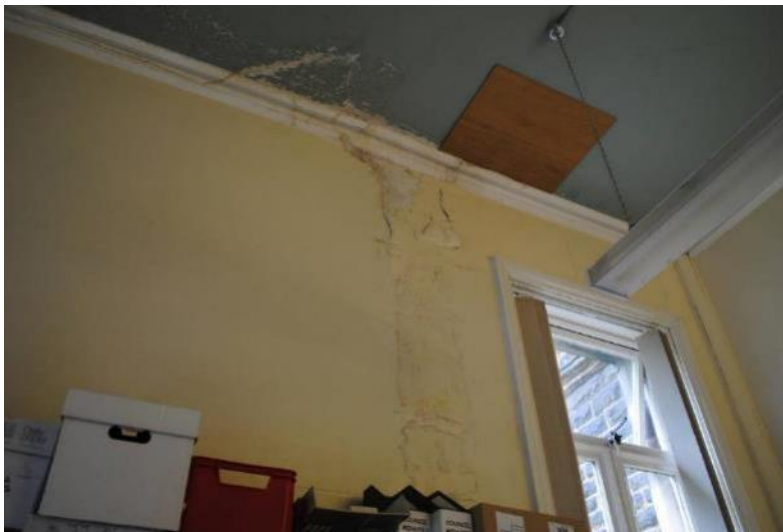
FIGURE 40 – EXAMPLE OF WATER INGRESS DAMAGE

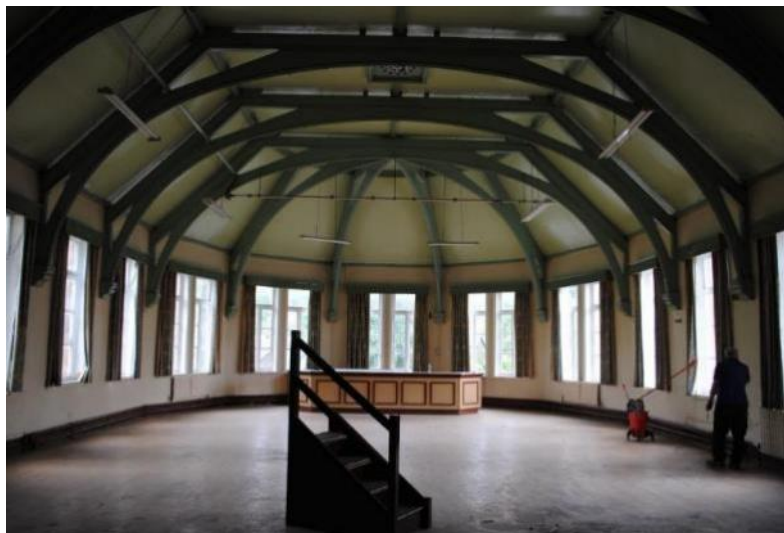
FIGURE 41 – FIRST FLOOR ASSEMBLY HALL

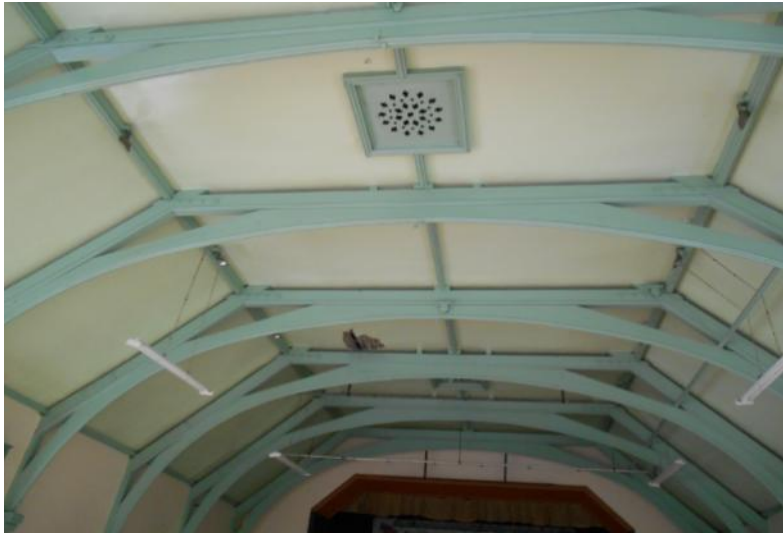
FIGURE 42 - ROOF OF FIRST FLOOR HALL

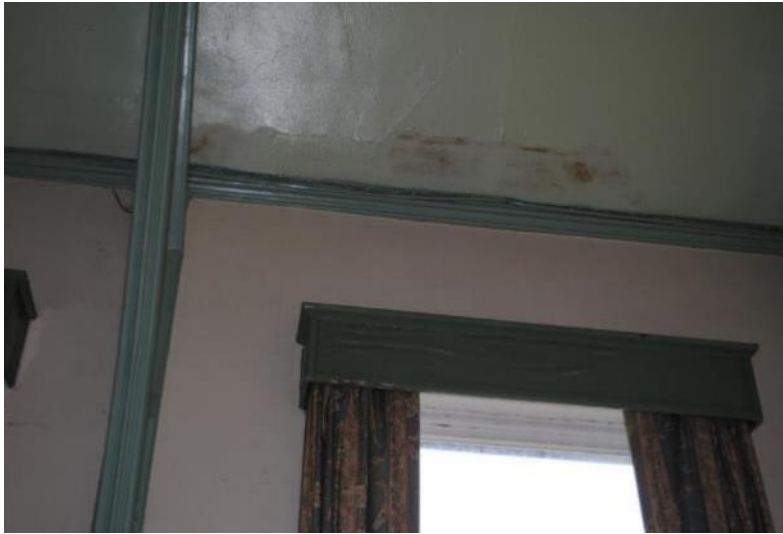
FIGURE 44 – EXAMPLE OF STAINING. THE STAINING IS AT THE SAME LEVEL AS THE PARAPET GUTTER

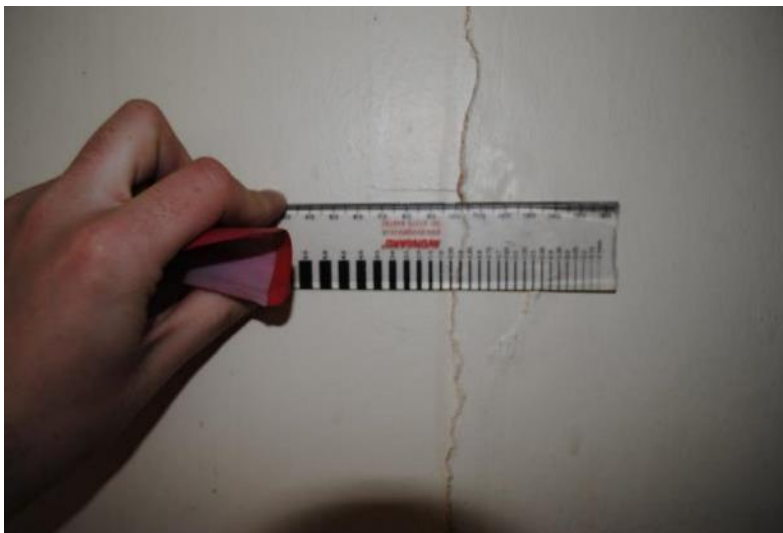
FIGURE 45 – CRACKING IN PLASTER, THOUGHT TO BE ATTRIBUTABLE TO WATER INGRESS

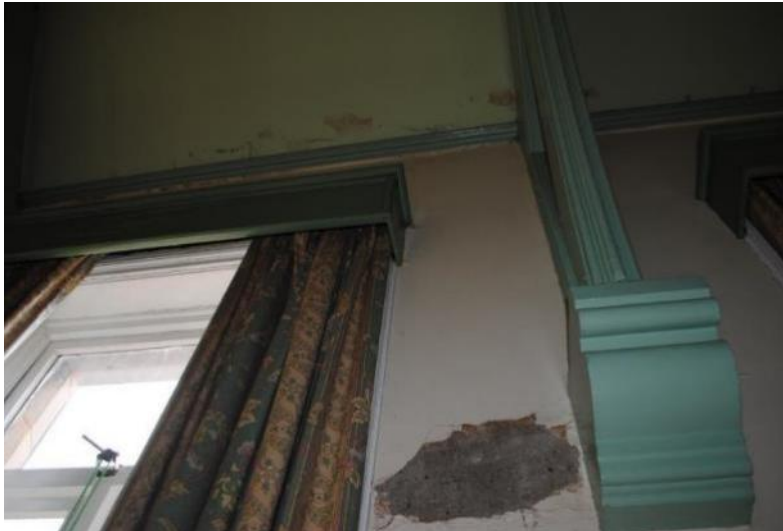
FIGURE 46 - EXAMPLE OF WATER DAMAGE TO PLASTER

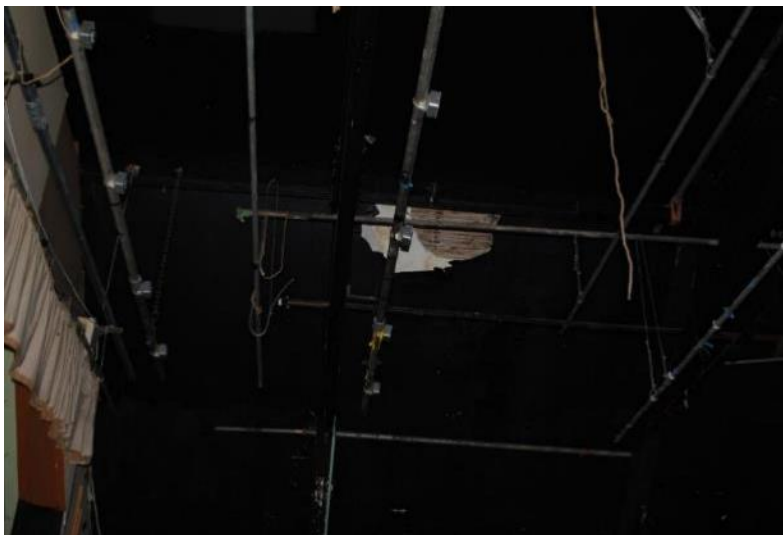
FIGURE 47 – PARTIALLY COLLAPSED CEILING ABOVE THE STAGE

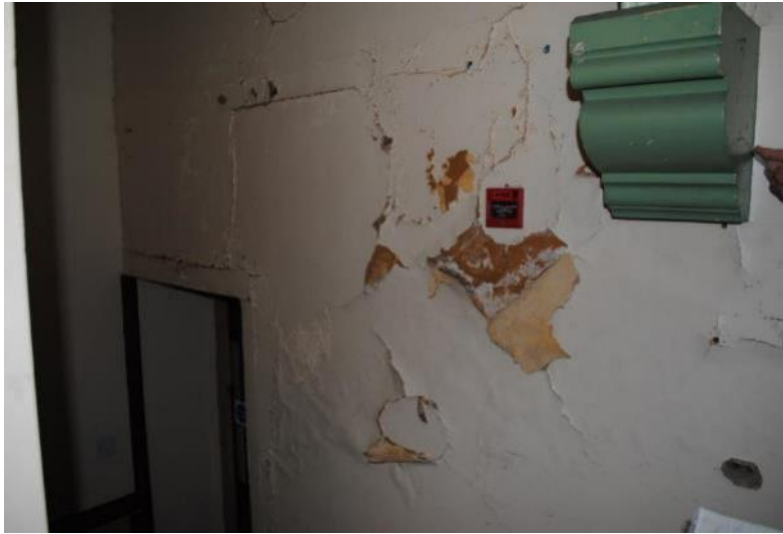
FIGURE 48 – EXAMPLE OF WATER DAMAGE

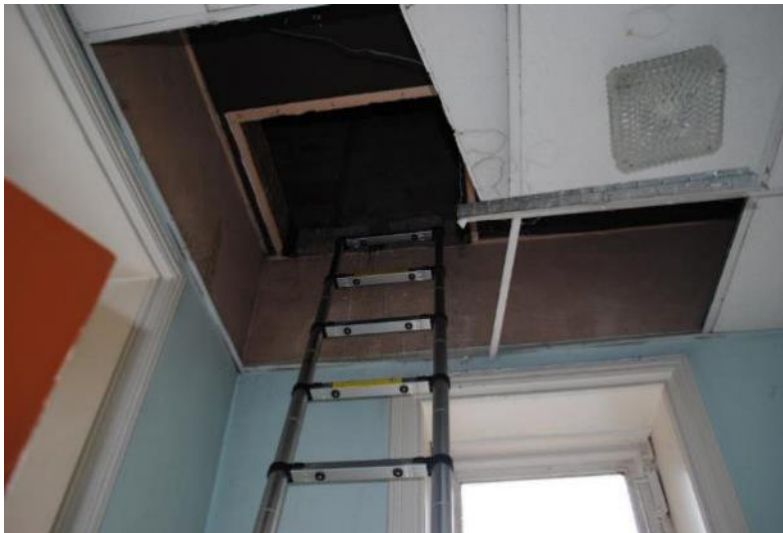
FIGURE 49 – ACCESS TO THE TOWER

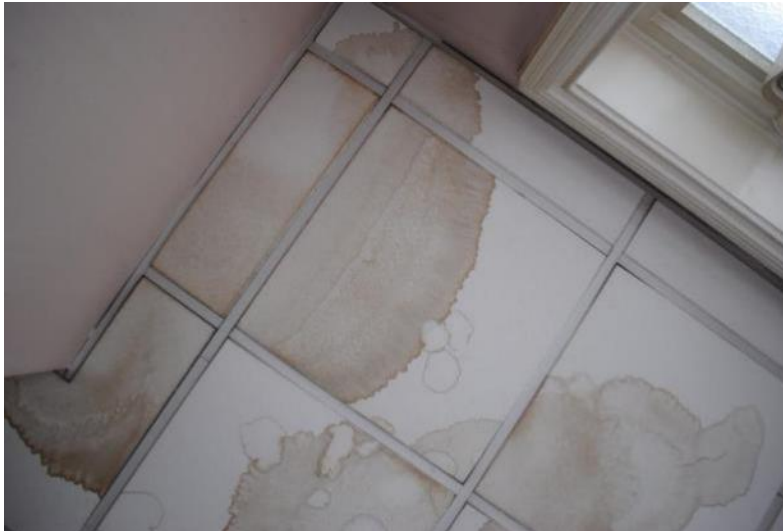
FIGURE 50 - WATER DAMAGE TO CEILING OF WOMEN'S BATHROOM.

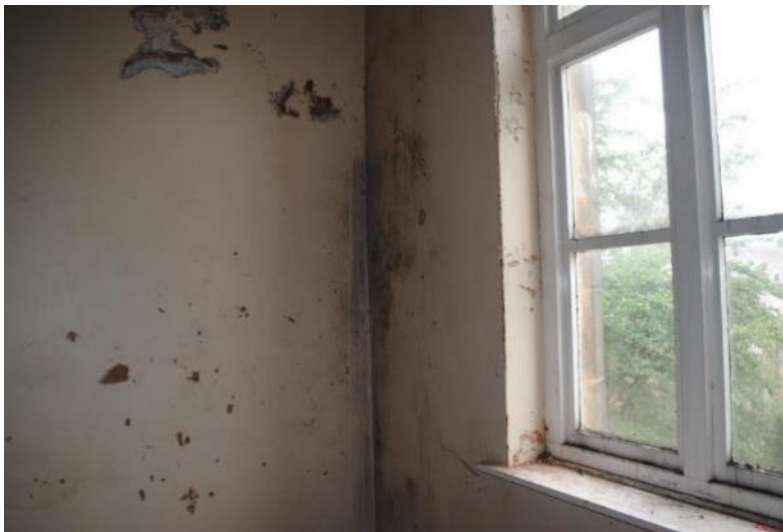
FIGURE 51 - FURTHER WATER DAMAGE TO WALLS

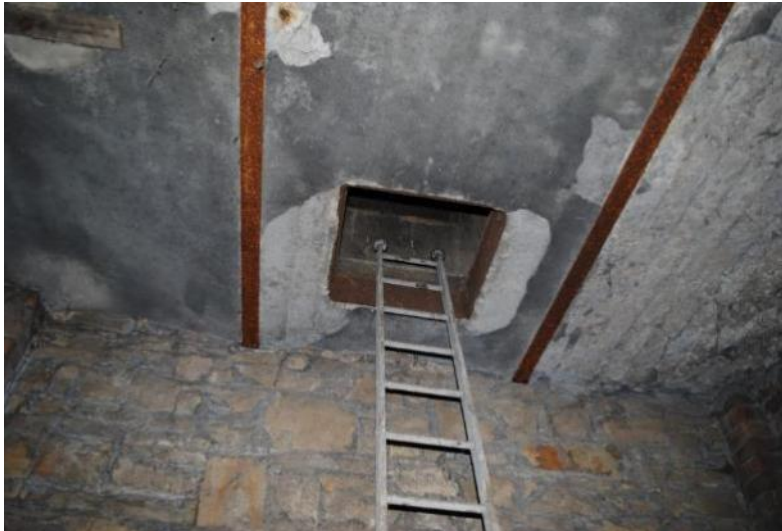
FIGURE 52 – EXAMPLE OF CORROSION TO STEELWORK

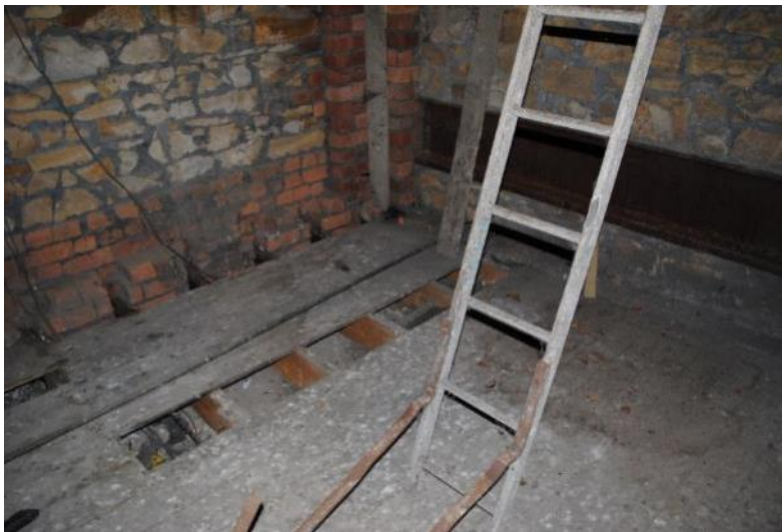
FIGURE 53 – TIMBER FLOOR COVERED IN PIGEON FOULING
