**An appraisal of trees
at
Taxal Edge Whaley Bridge**

prepared for Peter Dalton

September 2009

Oak-Leigh Ref: 09/019-report-NE.doc

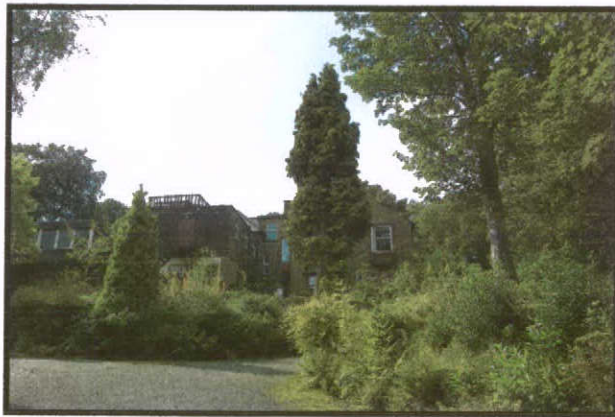
Photograph 1

- 2.2 **Brief site description:** Taxal Edge is situated to the south west of Whaley Bridge town centre. It is located on the southern side of the B5470 Macclesfield Road at Walker Brow. It comprises a substantial detached house set in capacious grounds. Over the years various ancillary buildings and annexes have been added around the original structure which I understand was recently used as an education establishment. The grounds are somewhat overgrown and neglected but remain well stocked with large mature trees and shrubs. The general nature of the locality is rural fringe (photograph 1)

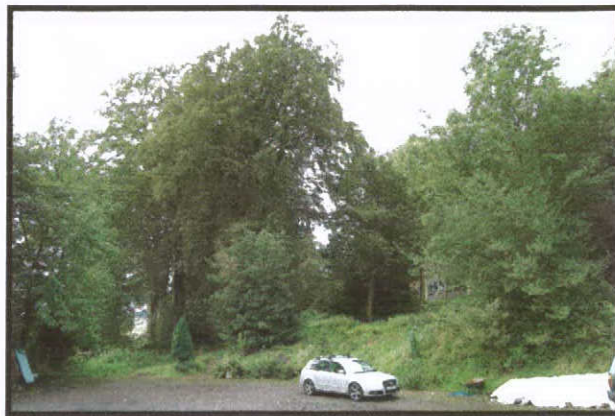
Photograph 2

- 4.5 **Trees to the south of the main house:** The trees at the southern end of the site (to the south of the pink line on the plans) have not been included in this report because they are well away from the main area of development and will not be directly affected by the proposals. Nevertheless, it should be noted that these trees will be afforded full protection because they stand behind trees closer to the development area that will be retained and protected.
- 4.6 The most prominent trees in this area are the large mature Common Beech that stand to the south and east of the outlying detached house to the south west of the main buildings (photograph 2).

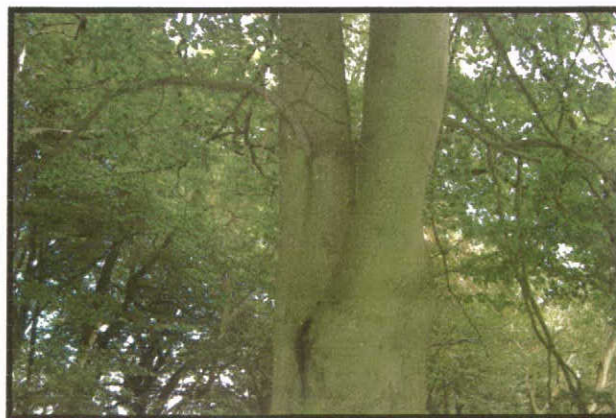
Photograph 3

- 4.7 The overall canopy structure of these trees is typical of a fully mature Beech tree appearing as a tall, spreading domes with low pendulous branches hanging down in their lower crowns. Certain structural abnormalities were observed in the crowns of several trees; chiefly potentially weak included forks (photograph 3) and crossing / fused branches (photograph 3).

- 4.8 Included forks are a characteristic that has the potential to develop into a serious structural defect. The branches will grow away from each other and, as they increase in size and begin to grow outwards cracks may begin to form between them. The gradual effect is similar to wedges driving them apart at the base of the fork resulting in an increased risk of splitting, although this risk cannot be accurately calculated.

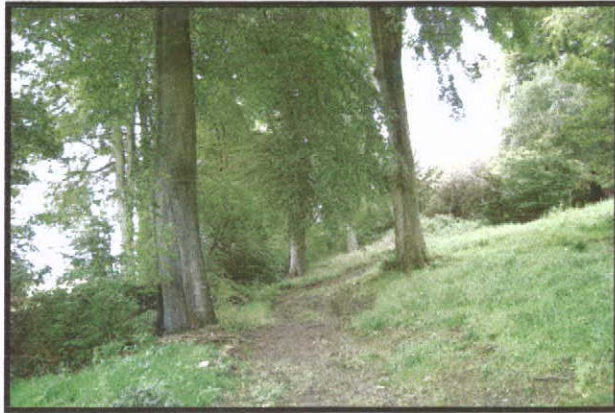
Photograph 4

- 4.9 This is particularly relevant to tree 18 Beech, which stands immediately to the rear of the outlying house. This tree has a severely included main fork and its crown encroaches onto the roof and rear elevation of the house. Because of its poor structural form and location close to the house, this tree should be removed irrespective of the proposed development.
- 4.10 I also noted that rough track has been formed beneath the canopies of four of these trees (tree 5, tree 7, tree 22 and tree 23). This track leads up to the outlying house and appears to have had little recent use (photograph 4).

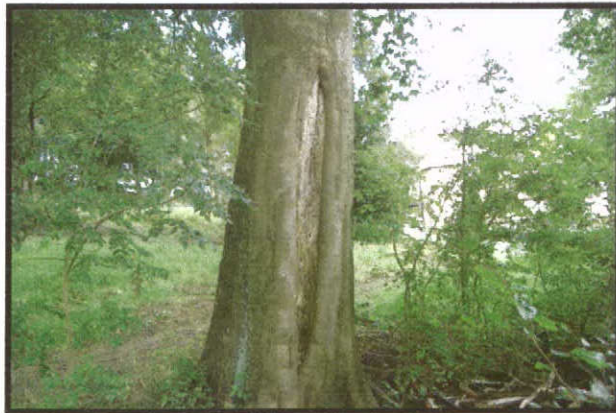
Photograph 5

- 4.11 Nevertheless, because this track runs over the root zones of these trees it would be sensible to monitor the health of these trees in the future. Irrespective of this tree 5 has a large wound at its base with dysfunctional tissue extending 300 millimetres into the stem (photograph 5).

| Tree No. | Species (common and latin) | Appr. Height (m), | Appr. Crown Spread | Appr. Stem dia. At 1.5 m (mm) | Appr. Canopy Height (m) | Age Class | Observations | Preliminary Management Recommendations | Estimated Remaining Contribution (years) | BS: 5837 Category Rating |
|--|---|---|---|---|---|---|--|--|--|---|
| T5. | Common Beech (<i>Fagus sylvatica</i>) | 25 | n5 s6 e6 w6 | 1100 | 5 | Mat | Very large specimen Tall single stem Open cavity in lower stem from 0.25m – 2.5m Decay in cavity extending up to 300mm into stem Significant deadwood Within 1.5 metres of unmade track Early symptoms of Beech Bark Disease (<i>Cryptococcus fagisuga</i>) on stem | Crown clean Retain and protect with a barrier complying with BS 5837 : (2005) or better Monitor progression of decay in stem cavity Consider eventual removal | 30 - 40 | C |

- 4.12 Particular attention should be paid to this tree as because of this defect and its future treatment (felling or pollarding) should be considered in light of the current or any subsequent development proposals in its vicinity.
- 4.13 There are other lesser trees in this area that should be removed irrespective of the proposed development. Tree 11 Willow, tree 12 Beech and the saplings in group 16 are all poor specimens that are impinging on the house and their removal would not be contentious.

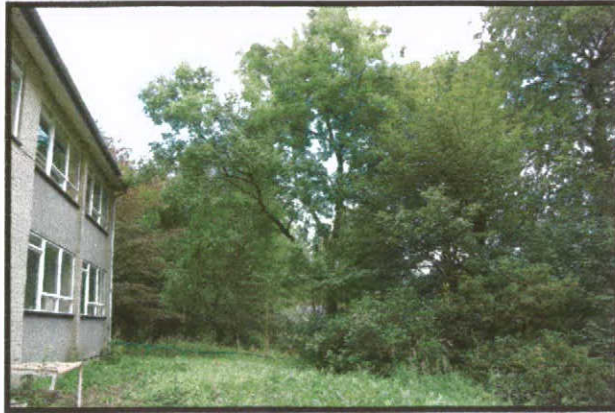
Photograph 6

- 4.14 The larger trees that stand at the front of the outlying house, tree 19 Ash, tree 20 Sycamore and tree 21 Sycamore are more significant specimens. However, they are relatively poor, probably self-seeded specimens that are encroaching towards the front elevation of the house (photograph 6).

- 4.15 It would be prudent to remove these trees now to allow unhindered access and use of the outlying house during and after the refurbishment works.
- 4.16 The scrubby trees on the bank to the west of the outlying house tree 26 Sycamore, tree 27 Sycamore, tree 28 Pine and tree 29 Ash are also relatively poor specimens. They are offset from the main body of woodland (group 30) that runs along the western boundary of the site and do not contribute greatly to the amenity of the trees behind them (photograph 7).

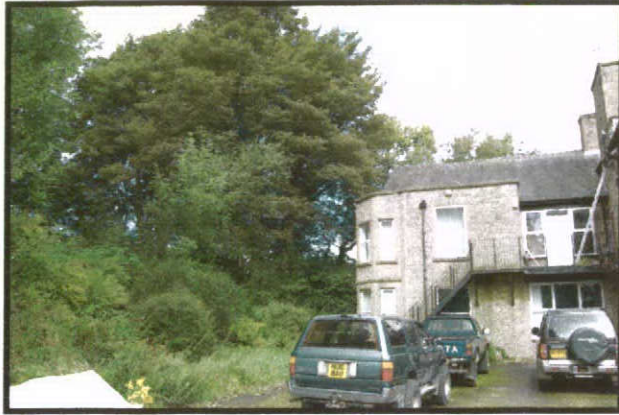
Photograph 8

- 4.17 The removal of these insignificant trees would allow space for the construction of a new access drive up to the outlying house. The woodland beyond these trees in group 30 could be protected and retained as an entity. Although, I would advocate some light thinning by removal of up to 20% of the poorest trees of this area particularly around the side and rear of the outlying house.
- 4.18 Further north tree 33 Sycamore and tree 34 Sycamore stand very close to the main house (photograph 8).

4.19 Tree 33 has developed a poor included fork at around 1.5 metres from ground level and should ideally be felled irrespective of the proposed development. The crown of tree 34 encroaches onto western elevation of the main house. It should be crown cleaned and lifted to provide an adequate clearance if it is to be retained. It should be noted that both these trees stand behind the low stone wall that appears to denote the western boundary of the site. It may therefore be possible that the ownership of these trees lies with a third party (see 6.2).

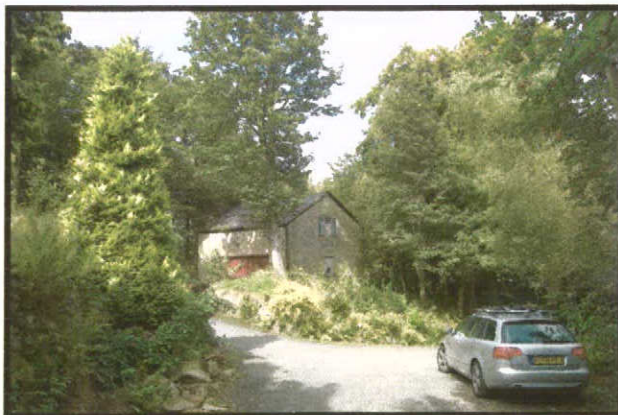
Photograph 9

4.20 **Trees to the north of the main house:** The trees to the north of the main house are similar in age, size and species to those that lie to the south. Generally, they stand around and beyond a substantial two storey double garage that faces the entrance to the main house (photograph 9).

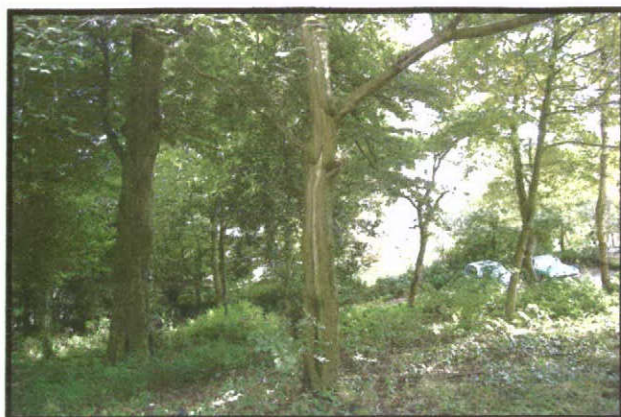
Photograph 10

- 4.22 There is an early-mature Elm located immediately to the north of the garage building. This tree should also be removed because it is poor specimen with a severe bark wound extending up its stem (photograph 10).

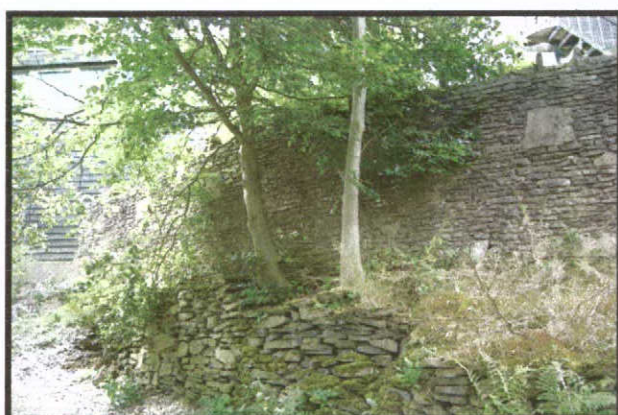
Photograph 11

- 4.23 **Trees around main house:** There are several other trees situated around the main house that have not been included on the topographical survey. The majority of these trees are self-seeded Sycamore and Ash that have grown up in recent years after the grounds became neglected (photograph 11).

- 4.24 Many of the Sycamores are located behind the stone wall on the western boundary and are contemporaneous to tree 48. All these self-seeded trees should be removed before they develop further and become more difficult and costly to remove. Realistically therefore, the only realistic option with regard to these poor trees is to remove them all as soon as is reasonably practicable. They have been marked with blobs of red paint for ease of identification.
- 4.25 The Cypress that stands adjacent to the steps at the entrance to the main house is a fairly prominent specimen. Unfortunately, pressures exerted from incremental root growth beneath and behind them are now disrupting these steps (photograph 12). I would advise that this tree and the other sporadic ornamental trees and shrubs around the main house be removed to allow unimpeded access during the proposed renovation works.
